# **8XC196NP**

## **SPECIFICATION UPDATE**

Release Date: September, 1996

Order Number 272838-002

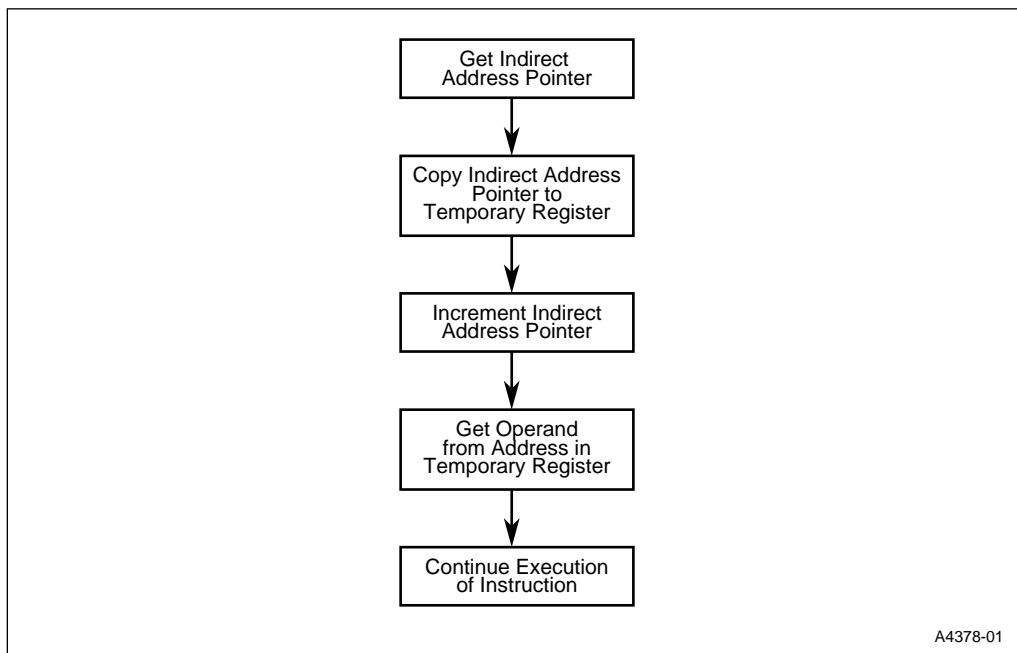
**PROBLEM:** For indirect addressing with autoincrement, a pointer that points to itself results in an access to the incremented pointer address rather than the original pointer address.

The CPU stores the pointer's value in a temporary register, increments the pointer, then accesses the operand at the address contained in the temporary register, as shown in this flowchart.

Therefore, if the pointer points to itself, the CPU accesses the operand at the incremented address contained in the pointer.

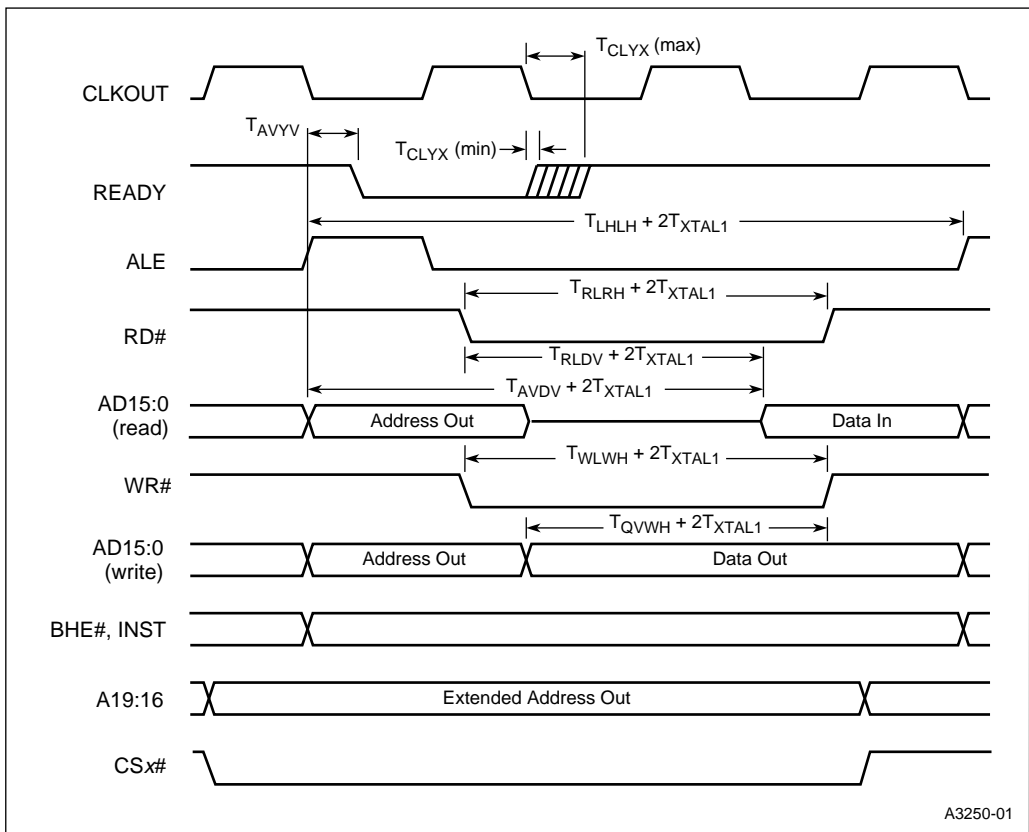
Figure 7. READY Timing Diagram (Multiplexed Bus Mode)

The value  $2T_{XTAL1}$  was incorrectly shown as  $T_{XTAL1}$  in the READY timing diagrams. The following two figures replace Figure 7 and Figure 9 in the datasheet.
