# 80960Jx Processor

Specification Update

*February 1999*

Order Number: 272852-007

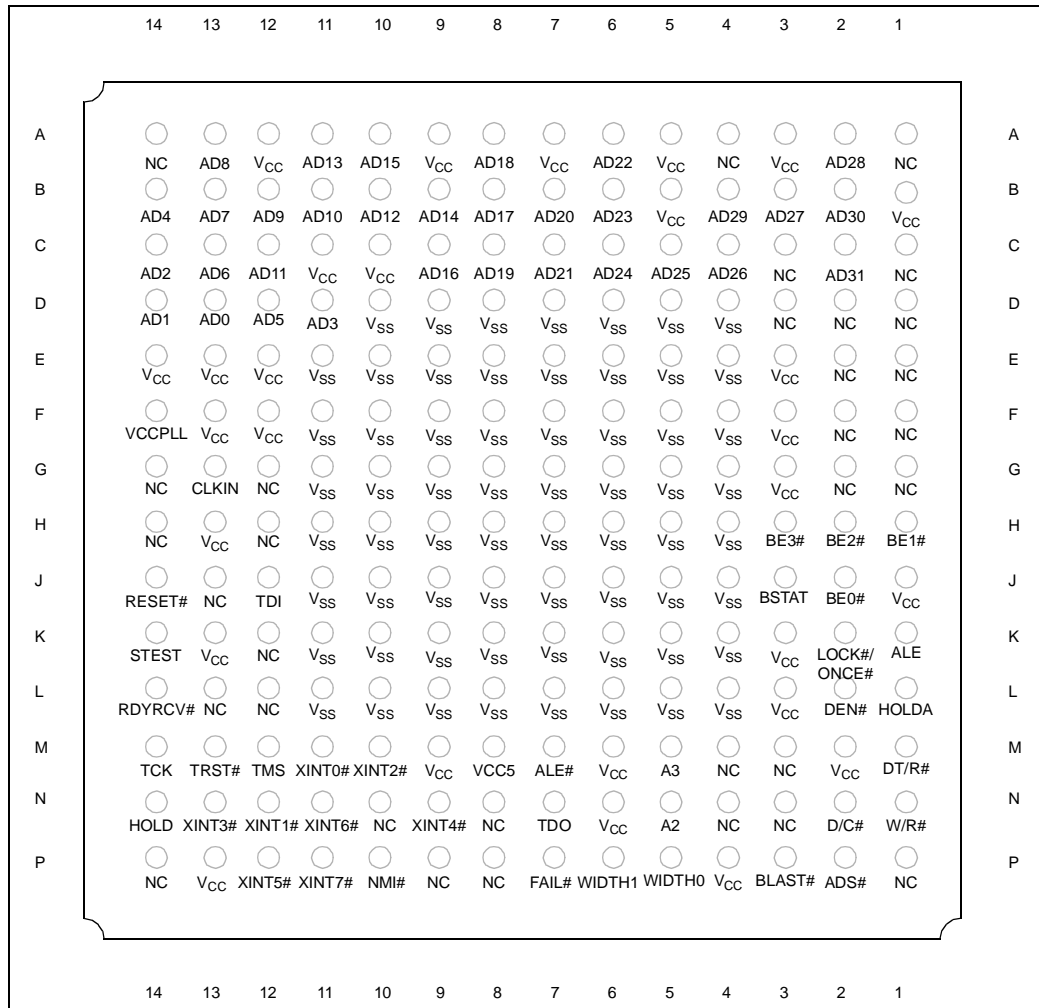
**Figure 7. 196-Ball Mini Plastic Ball Grid Array Bottom View - Balls Facing Up**

Figure 7 is the bottom view, “Balls Facing Up,” and should be oriented as shown:

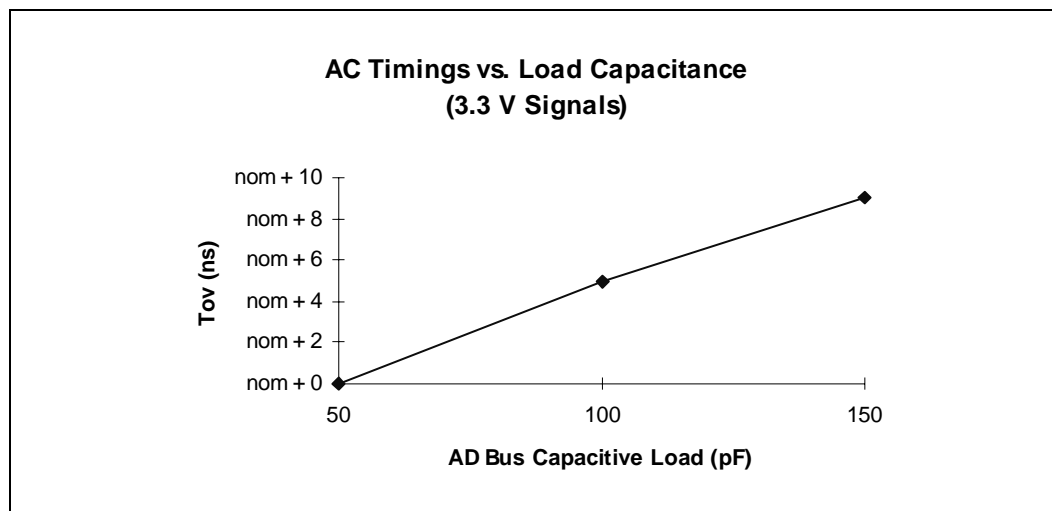
#### Output Delay or Hold vs. Load Capacitance (3.3 V Signals)

**Problem:** *80960JA/JF/JD/JT 3.3 V Microprocessor* datasheet, the “Output Delay vs. Load Capacitance” diagram and the “TLX vs. AD Bus Load Capacitance” diagrams do not apply to the 80960JT microprocessor (they are correct, however, for the JA/JF/JD microprocessors). The following diagrams and related notes provide the correct derating curve information for the 80960JT microprocessor:

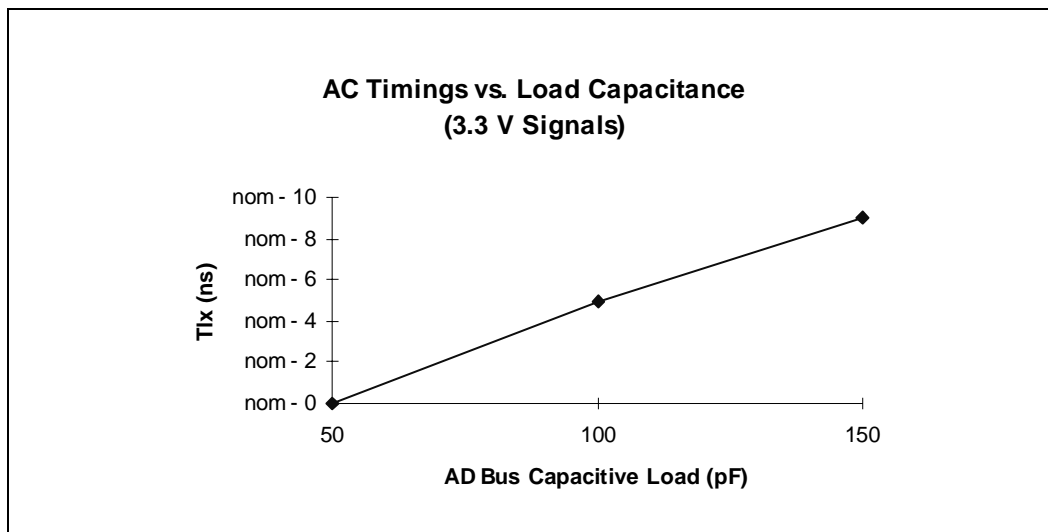
**T<sub>LX</sub> vs. AD Bus Load Capacitance (3.3 V Signals)**

**Note:** The T<sub>LX</sub> Derating curve applies only when an imbalance in the capacitive load occurs between the AD bus and ALE. The T<sub>LX</sub> derating is based on a 50 pF load on ALE. The derating applies to ALE and ALE#.

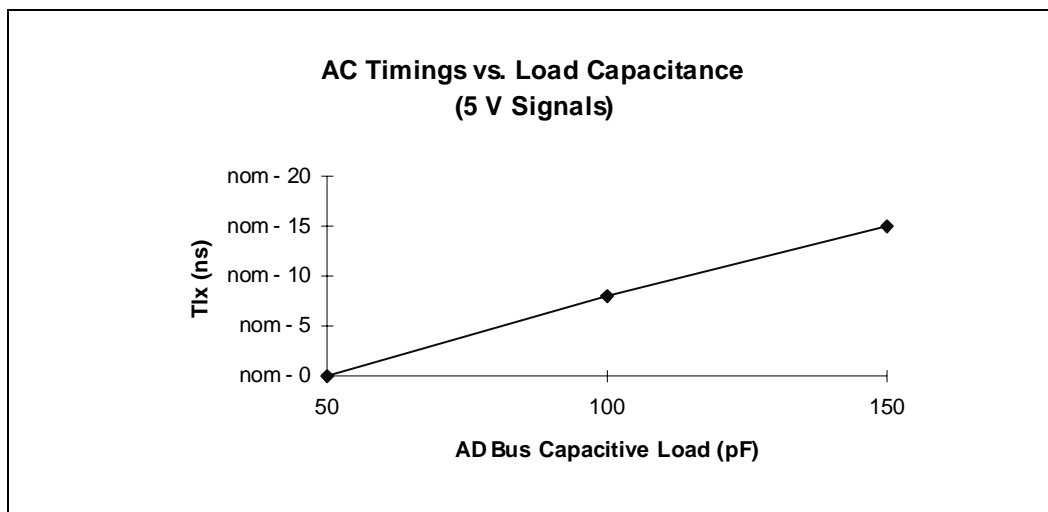
**T<sub>LX</sub> vs. AD Bus Load Capacitance (5 V Signals)**

**Note:** The T<sub>LX</sub> Derating curve applies only when an imbalance in the capacitive load occurs between the AD bus and ALE. The T<sub>LX</sub> derating is based on a 50 pF load on ALE. The derating applies to ALE and ALE#.
