87C196JQ SPECIFICATION UPDATE

Release Date: April, 1997
Order Number: 272857-003

The 87C196JQ may contain design defects or errors known as errata. Characterized errata that may cause the 87C196JQ's behavior to deviate from published specifications are documented in this specification update.

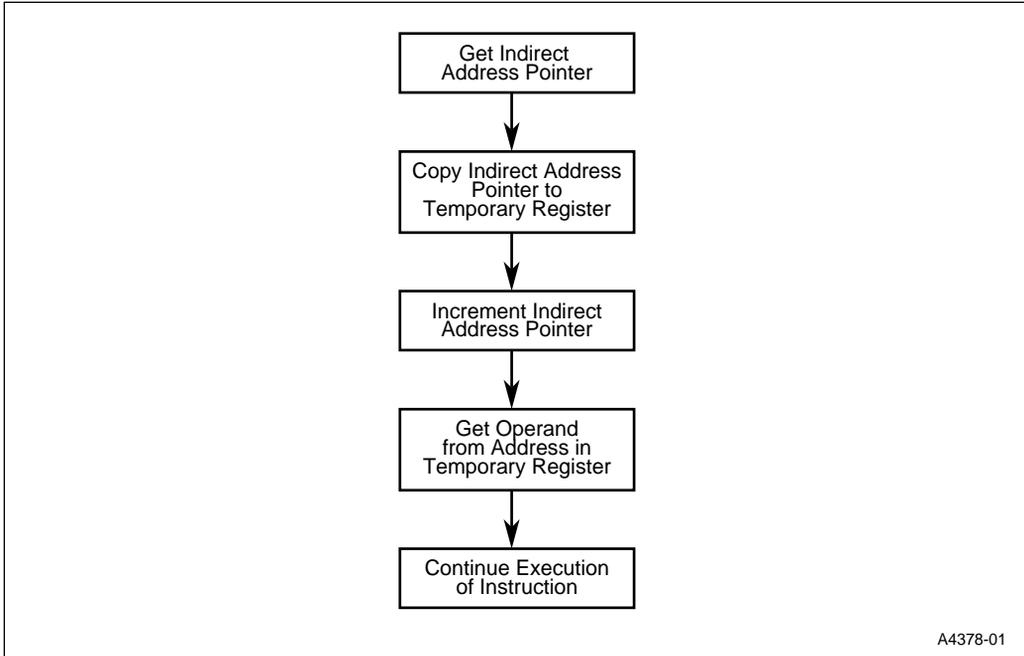
008. Indirect Addressing With AutoIncrement

PROBLEM: For indirect addressing with autoincrement, a pointer that points to itself results in an access to the incremented pointer address rather than the original pointer address.

The CPU stores the pointer's value in a temporary register, increments the pointer, then accesses the operand at the address contained in the temporary register, as shown in this flowchart.

Therefore, if the pointer points to itself, the CPU accesses the operand at the incremented address contained in the pointer.

WORKAROUND: Avoid using an indirect address pointer that points to itself.

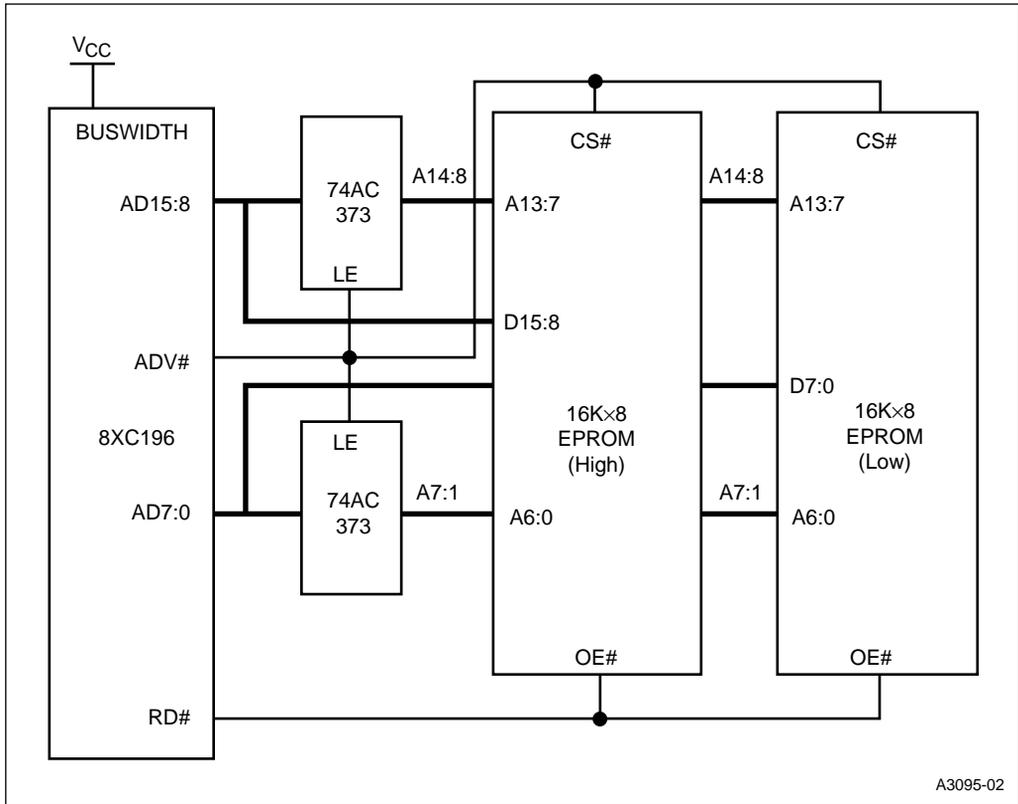
Figure 1. 16-bit System with EPROM

001. *High address inputs to the low EPROM should be A14:8 in Figure 15-18.*

ITEM: The next revision of the user's manual will include the following corrected graphic.
