87C196JV 20 MHz Specification Update

Automotive

December 1998

Order Number: **272860-006**

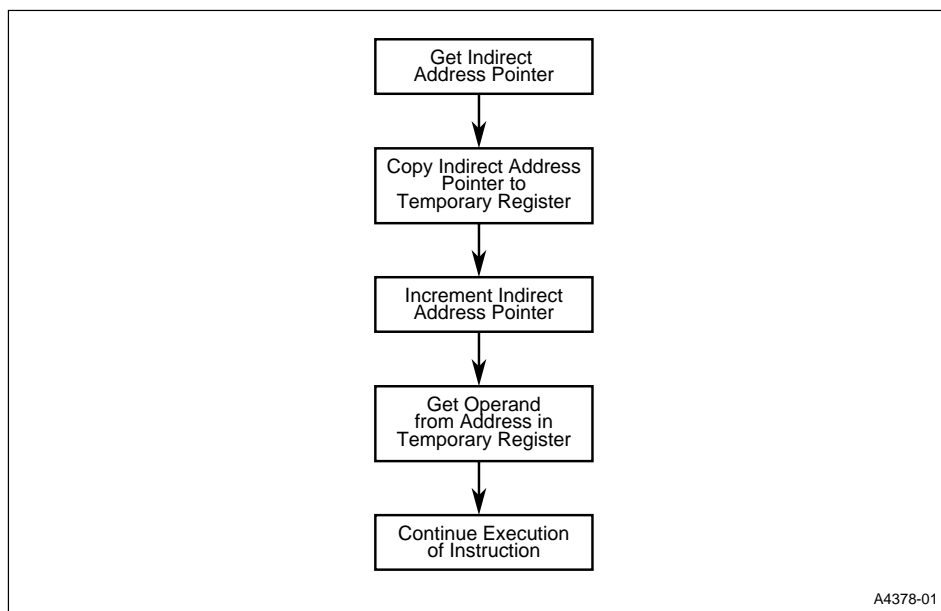
8. Indirect Addressing With AutoIncrement

Problem: For indirect addressing with autoincrement, a pointer that points to itself results in an access to the incremented pointer address rather than the original pointer address.

The CPU stores the pointer's value in a temporary register, increments the pointer, then accesses the operand at the address contained in the temporary register, as shown in this flowchart.

Therefore, if the pointer points to itself, the CPU accesses the operand at the incremented address contained in the pointer.

Workaround: Avoid using an indirect address pointer that points to itself.

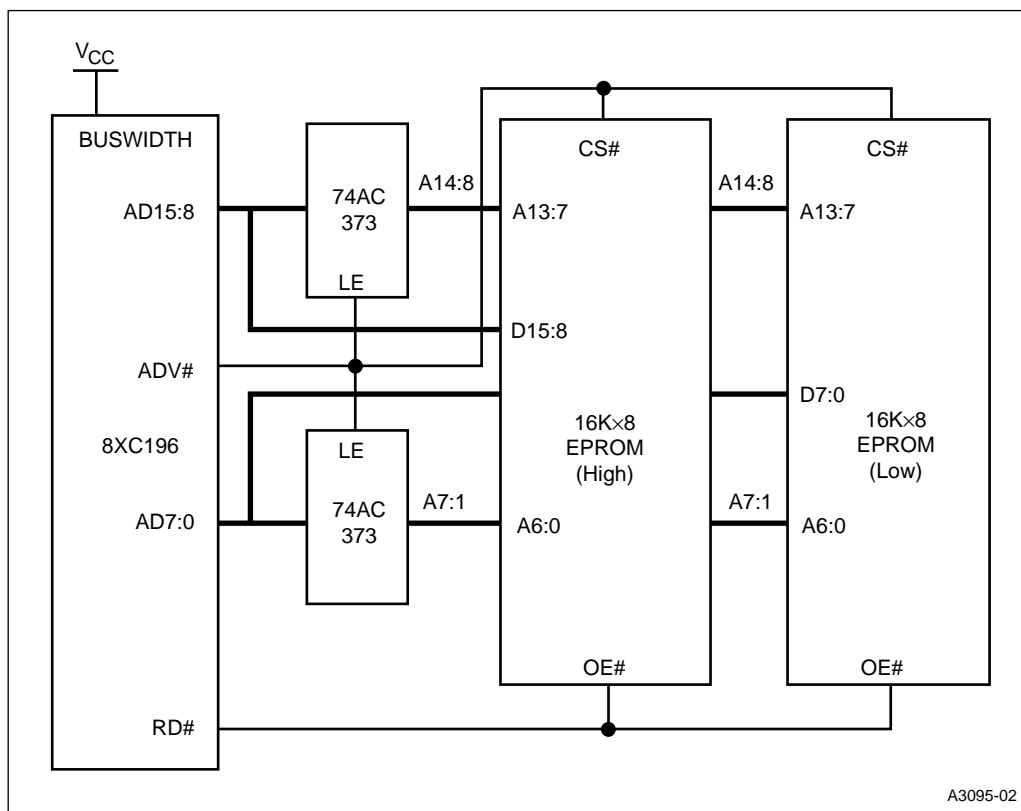
Figure 1. 16-bit System with EPROM

1. High address inputs to the low EPROM should be A14:8 in Figure 15-18

Issue: The next revision of the user's manual will include the following corrected graphic.
