Intel386™ EX Embedded Processor

Specification Update

October 1998

Order Number: 272873-010

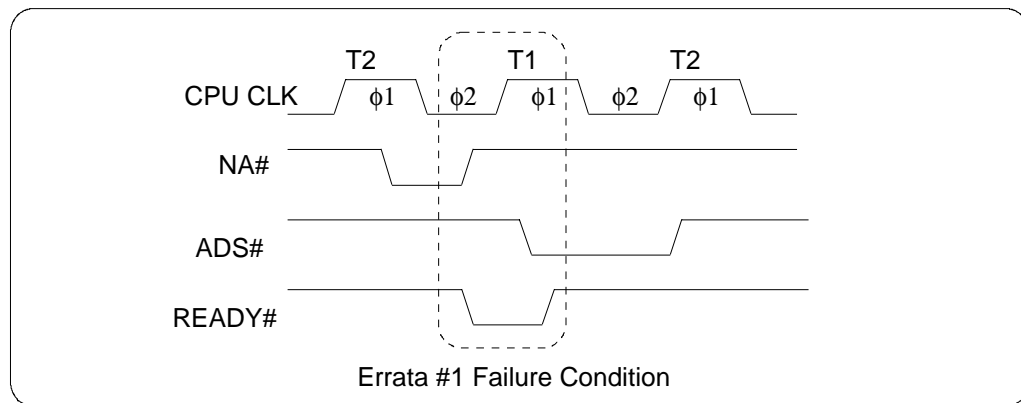
1. Watchdog Timer (WDT) Bus Monitor Failure During Bus Pipeline Operation

Problem: The errata applies to the WDT unit when using the Bus Monitor Mode and Bus Pipeline operation. If a pipelined bus cycle is requested at the same time the current bus cycle is completed, the WDT down counter is not reloaded or stopped. This condition means that the WDT could time-out and erroneously report a system failure. The waveform below shows the errant condition.

The errata condition is caused by the system generating READY# immediately after NA# has been requested, and a T1 cycle is generated (rather than a T2P cycle). Essentially, the system is requesting a pipelined access, but does not need it because READY# has been returned. Such a condition is not typically expected when using the pipeline feature.

Workaround: Ensure that READY# is not generated after a pipelined bus operation is requested. See the example waveform below.

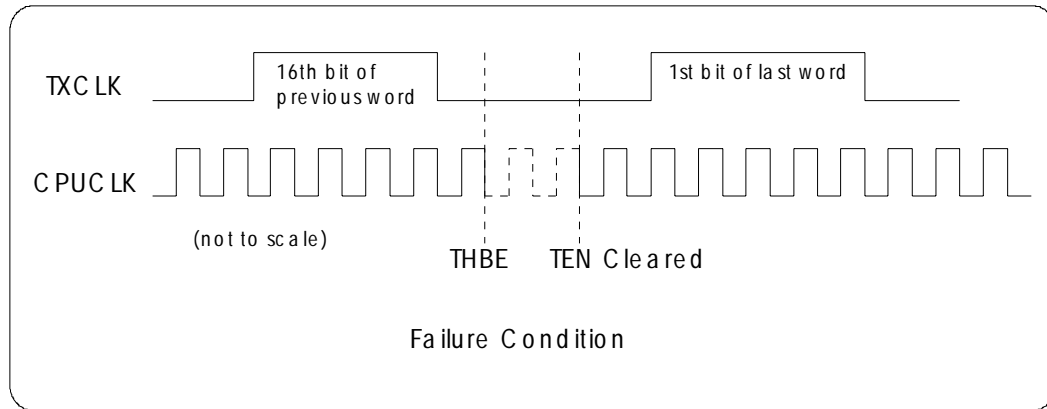
Problem: When the SSIO is transmitting data (master or slave mode) the transmitter is turned off by clearing the TEN bit of the SSIOCON1 register. One way of indicating to the software to clear this bit is by waiting for the Transmit Holding Buffer Empty (THBE) signal to go active, indicating that the word written to the holding register is ready for transmission from the shift register. Even if the software waits for this signal and then writes to SSIOCON1 to disable TEN, depending on when TEN is cleared, the last word transmit may or may not take place.

If the TXCLK is significantly slower than the CPUCLK, it is possible for the THBE bit to be set and the TEN bit to be cleared all during the low time of the TXCLK (see diagram). In this case, even though the last word to be transmitted has been loaded into the shift register, it will not be shifted out.

Workaround: In order to assure that the last word is transmitted, the TEN bit must not be cleared until after the TXCLK transitions from low to high when the 1st bit of the last word is being transmitted. Consequently, the way to assure that this happens is to either: 1) utilize a timer to assure that enough time elapses from when the THBE bit goes high until the TXCLK goes high, or 2) execute a fixed number of NOPs after THBE goes high before clearing TEN. In either case, the length of the delay is dependent upon the frequency of TXCLK and the CPUCLK.

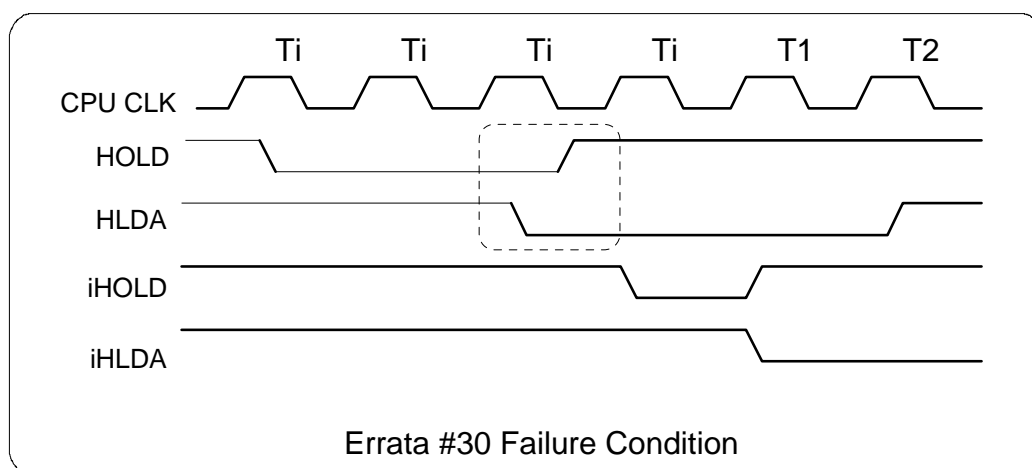
30. HLDA Inactive To HOLD Active Arbitration Could Improperly Float The Bus

Problem: In a HOLD/HLDA cycle the HOLD signal must not be re-asserted until after HLDA is returned inactive. If, however, HOLD is asserted in the same T-state that HLDA goes inactive a problem may occur where the bus arbiter relinquishes control to the core and at the same time floats the bus by asserting the HLDA pin. The following waveform shows the conditions that cause this error. The signals iHOLD and iHLDA are internal signals and represent the HOLD input to the core and the HLDA output from the core (equivalent to the HOLD and HLDA signals on a Intel386™ SX processor). In this diagram a T1 occurs because a request was pending by the core during the previous HOLD cycle. One T-state after the arbiter releases the bus (HLDA = 0) it removes its iHOLD, and then the core removes iHLDA. As soon as the iHLDA is released, the T1 state starts. However, because of the timing of the next HOLD request, the bus arbiter re-asserts iHOLD and HLDA even though the core has not asserted iHLDA. The result is that the core continues to run its bus cycle and, at the same time, the bus arbiter has floated the external bus. It is also possible for the following to occur when HOLD/HLDA arbitration is at issue: HOLD is driven active during the T1 or Tw of a valid bus cycle. The processor begins the next bus cycle and generates HLDA. HLDA is active for only one T-state. ADS# is extended through the bus cycle. The alternate bus master sees the HLDA and performs its bus activity. HOLD is then driven inactive and the bus is returned to the Intel386™ EX Processor. At this point there is bus contention.

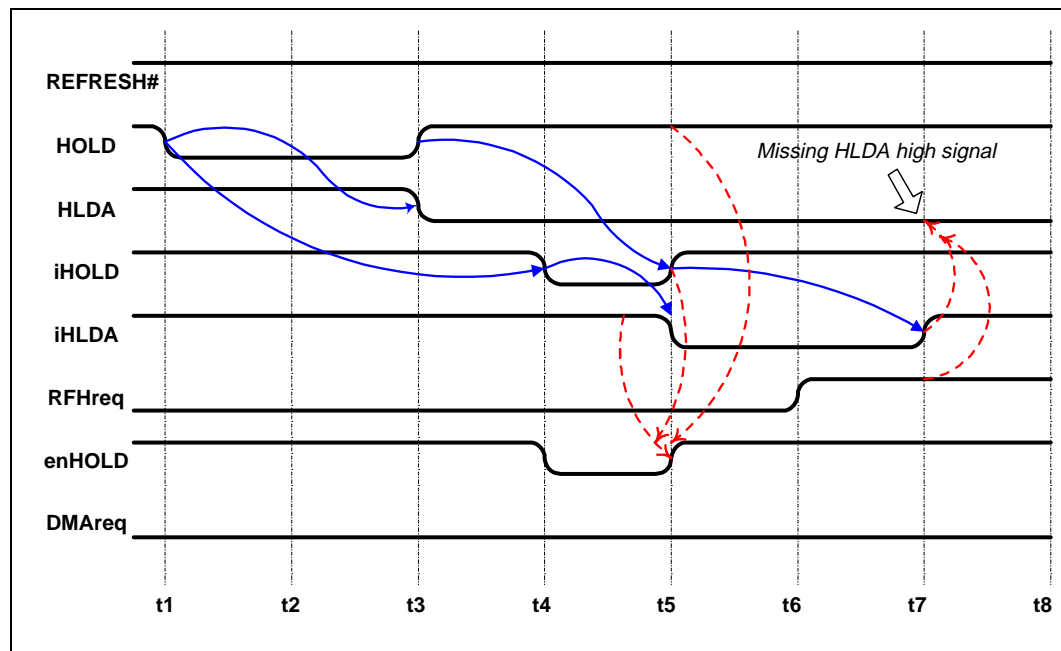
Figure 4. Quick HOLD Assert and Deassert with Slow REFRESH Interval

- b. HOLD is removed and reasserted within one bus cycle. Refer to Figure 4. This condition will cause the problematic window with fast iHOLD deassertion (t4) and assertion (t5). Note that if HOLD is deasserted because of pending REFRESH and reasserted again within one bus cycle, the problem will not occur since the iHOLD signal is never deasserted due to refresh. The reassertion of the HOLD would then be serviced upon completion of the refresh.

Workaround: If the situations listed in conditions #1 and #2 cannot be avoided, the user needs to synchronize the external HOLD request such that it does not go active in an idle bus cycle or a refresh cycle. Alternately, HOLD can be deasserted if a HLDA is not received within a time-out period, as described in workaround 2. A third listing describes another recommended workaround when using HOLD, DMA, and REFRESH.

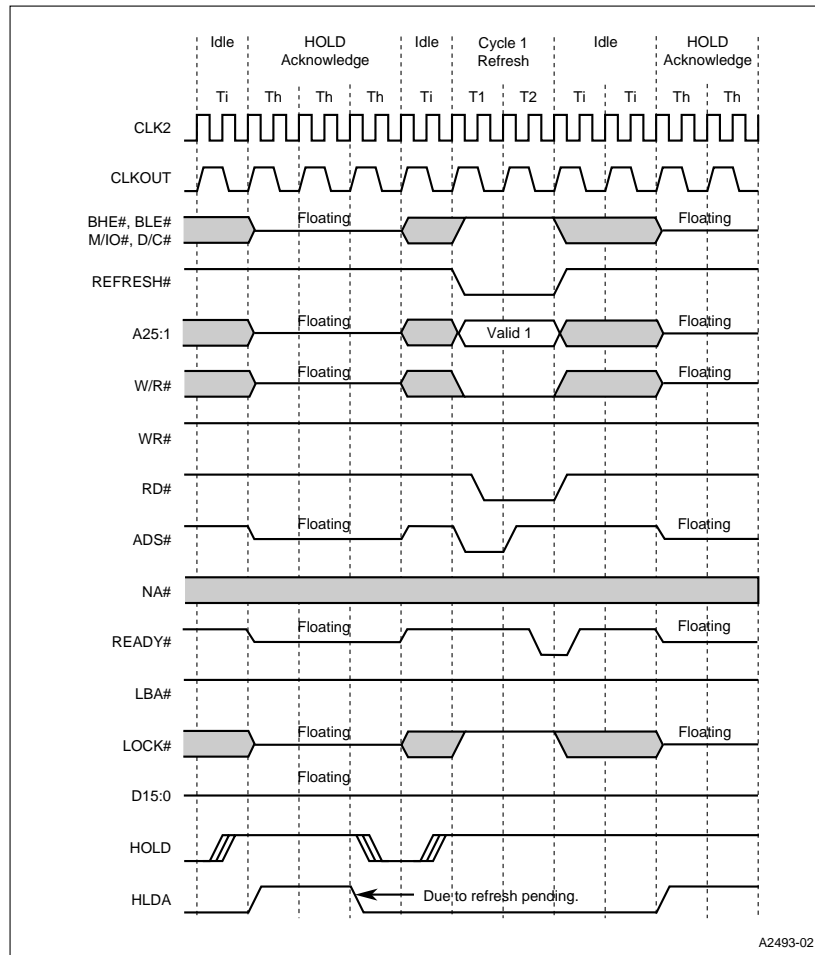
11. 272485-002, Section 6.3.6, Page 6-30, Figure 6-12.

Issue: Modified the ADS# and READY# waveforms to indicate floating. The corrected figure is shown below.
