Intel386™ EX Embedded Processor

Specification Update

August 2004

Order Number: 272873-011

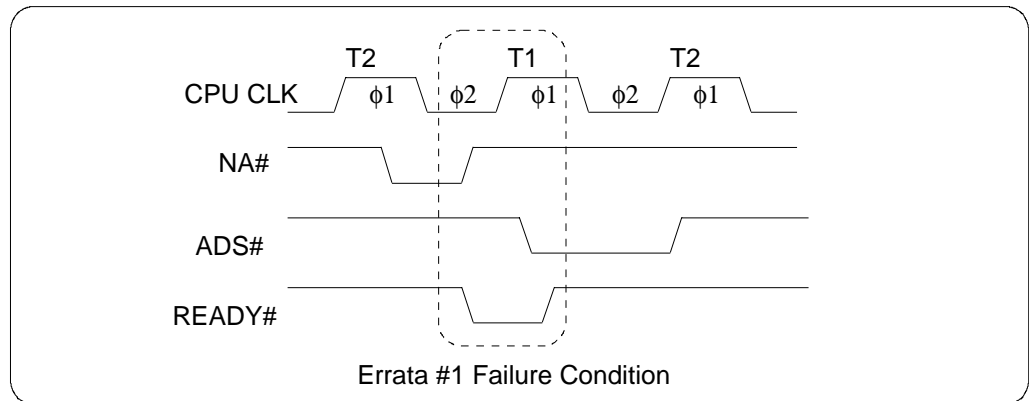
1. Watchdog Timer (WDT) Bus Monitor Failure During Bus Pipeline Operation

Problem: The errata applies to the WDT unit when using the Bus Monitor Mode and Bus Pipeline operation. If a pipelined bus cycle is requested at the same time the current bus cycle is completed, the WDT down counter is not reloaded or stopped. This condition means that the WDT could time-out and erroneously report a system failure. The waveform below shows the errant condition.

The errata condition is caused by the system generating READY# immediately after NA# has been requested, and a T1 cycle is generated (rather than a T2P cycle). Essentially, the system is requesting a pipelined access, but does not need it because READY# has been returned. Such a condition is not typically expected when using the pipeline feature.

Workaround: Ensure that READY# is not generated after a pipelined bus operation is requested. See the example waveform below.

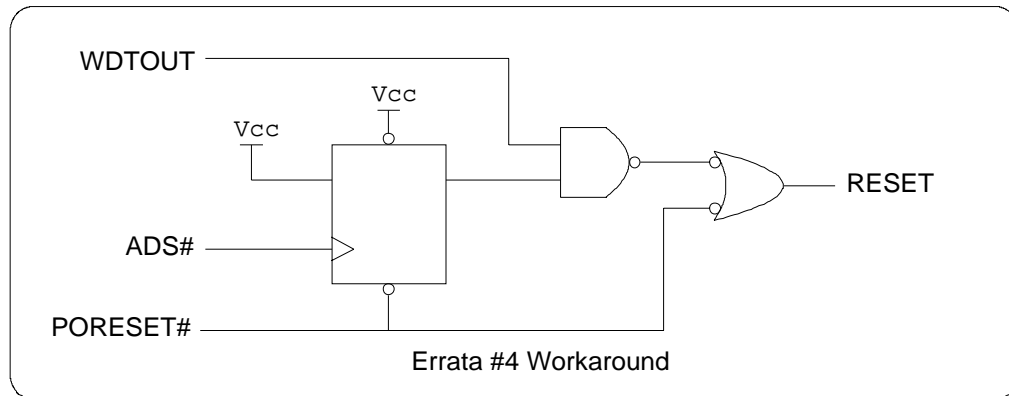
Implication: This errata only applies to a system design that uses the WDTOUT signal to generate a device reset. The WDT will time out and reset the device before the CPU self-test can complete.

Workaround: The WDTOUT signal cannot be directly tied to the RESET input during self-test since there is no mechanism to increase the default value loaded into the WDT counter. The circuit shown below can be used to block WDTOUT until the first ADS# is generated. The signal PORESET# is a power-on reset signal generated by the system. WDTOUT is an output of the Intel386 EX processor, and RESET is an input to the processor. Please note that the circuit below has not been tested in a real design and is provided as an example only.

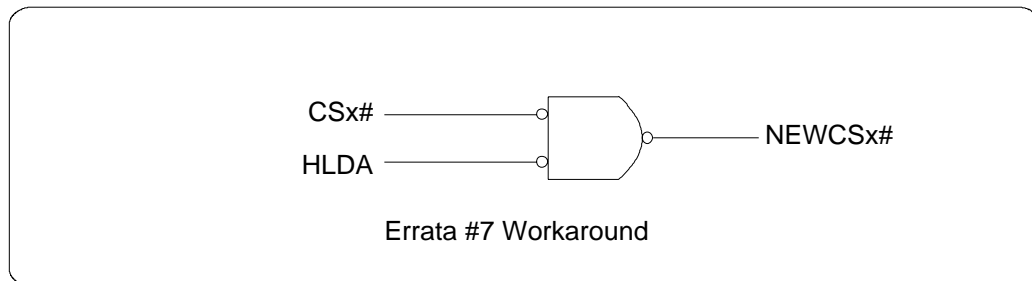
Problem: When the device enters a bus HOLD state because of a HOLD or DMA Cascade operation, the Chip Select that was valid in the previous cycle can remain active during the bus hold. This can cause bus contention when another bus master gains control of the bus.

Workaround: Qualify a chip-select with HLDA such as shown in the circuit below. The chip-select will go inactive if HLDA goes active. If using a PLD device, then HLDA should be used to qualify the chip-select as shown in the following diagram.

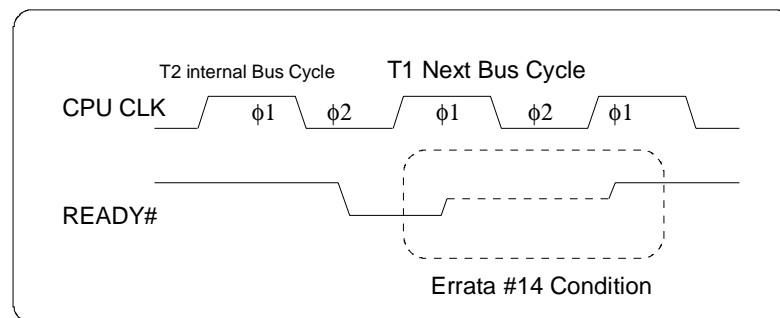
14. READY# Floats In T1 After Internal Bus Cycle Due to LBA#

Problem: During internal bus cycles, the LBA# signal does not remain active into the next T1 bus state, causing READY# to float during T1. This is unlike bus cycles controlled by the Chip Select Unit (CSU), where READY# is driven inactive during T1 of the next bus cycle.

Workaround: Pull-up READY# if the float condition will cause system logic to operate improperly.

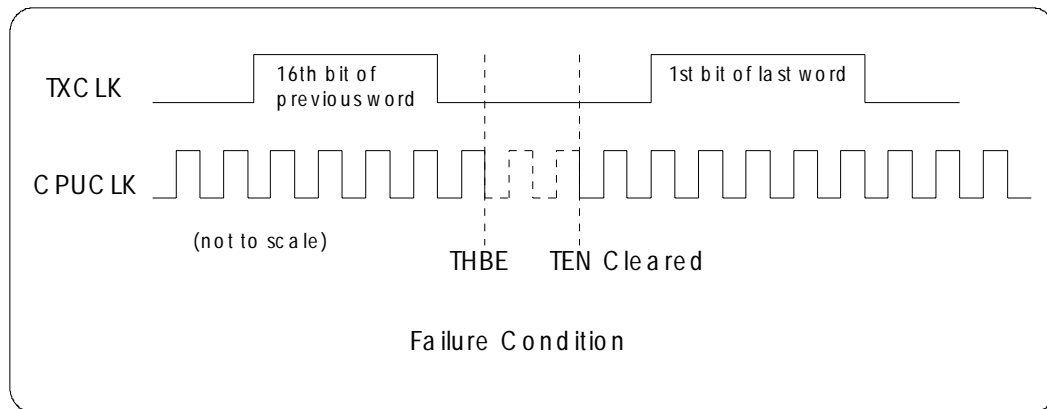
Problem: When the SSIO is transmitting data (master or slave mode) the transmitter is turned off by clearing the TEN bit of the SSIOCON1 register. One way of indicating to the software to clear this bit is by waiting for the Transmit Holding Buffer Empty (THBE) signal to go active, indicating that the word written to the holding register is ready for transmission from the shift register. Even if the software waits for this signal and then writes to SSIOCON1 to disable TEN, depending on when TEN is cleared, the last word transmit may or may not take place.

If the TXCLK is significantly slower than the CPUCLK, it is possible for the THBE bit to be set and the TEN bit to be cleared all during the low time of the TXCLK (see diagram). In this case, even though the last word to be transmitted has been loaded into the shift register, it will not be shifted out.

Workaround: In order to assure that the last word is transmitted, the TEN bit must not be cleared until after the TXCLK transitions from low to high when the 1st bit of the last word is being transmitted. Consequently, the way to assure that this happens is to either: 1) utilize a timer to assure that enough time elapses from when the THBE bit goes high until the TXCLK goes high, or 2) execute a fixed number of NOPs after THBE goes high before clearing TEN. In either case, the length of the delay is dependent upon the frequency of TXCLK and the CPUCLK.

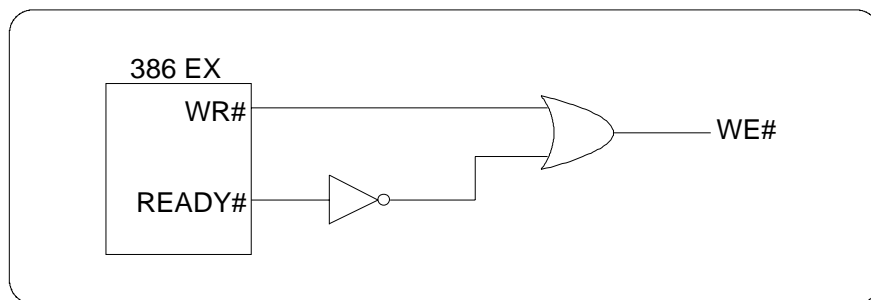
Implication: This errata applies to all applications that use the WR# signal as the write strobe to memory or I/O.

Workaround: The circuit shown below may be used to generate a write strobe if the READY# signal is not generated too early in the T2 cycle. Please note this circuit has not been tested in a real design and is provided as an example only. For applications which cannot use the circuit below it is necessary to implement an external WE# signal using a simple state machine design. An example of what that state machine could look like is available in the EV386EX evaluation board design, or in the Point of Sales Terminal reference design available from the WEB, BBS or through literature.

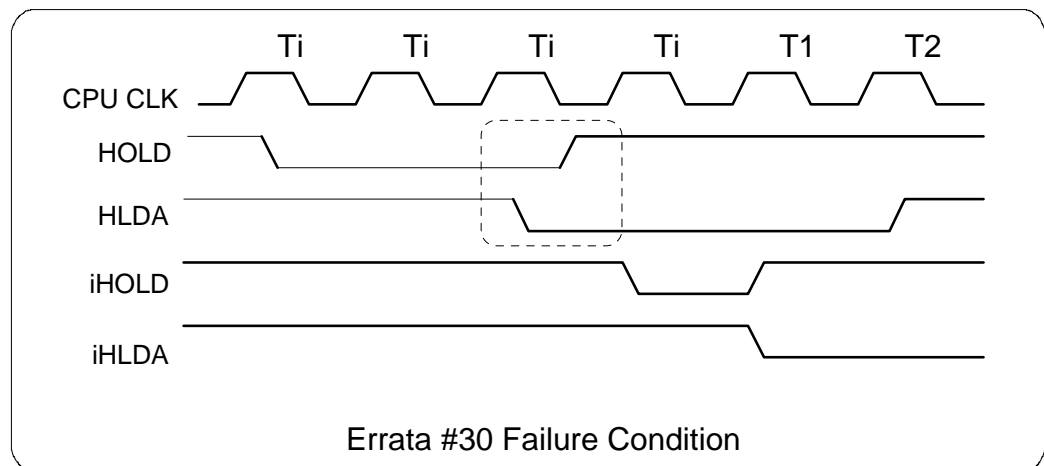
30. HLDA Inactive To HOLD Active Arbitration Could Improperly Float The Bus

Problem: In a HOLD/HLDA cycle the HOLD signal must not be re-asserted until after HLDA is returned inactive. If, however, HOLD is asserted in the same T-state that HLDA goes inactive a problem may occur where the bus arbiter relinquishes control to the core and at the same time floats the bus by asserting the HLDA pin. The following waveform shows the conditions that cause this error. The signals iHOLD and iHLDA are internal signals and represent the HOLD input to the core and the HLDA output from the core (equivalent to the HOLD and HLDA signals on a Intel386™ SX processor). In this diagram a T1 occurs because a request was pending by the core during the previous HOLD cycle. One T-state after the arbiter releases the bus (HLDA = 0) it removes its iHOLD, and then the core removes iHLDA. As soon as the iHLDA is released, the T1 state starts. However, because of the timing of the next HOLD request, the bus arbiter re-asserts iHOLD and HLDA even though the core has not asserted iHLDA. The result is that the core continues to run its bus cycle and, at the same time, the bus arbiter has floated the external bus. It is also possible for the following to occur when HOLD/HLDA arbitration is at issue: HOLD is driven active during the T1 or Tw of a valid bus cycle. The processor begins the next bus cycle and generates HLDA. HLDA is active for only one T-state. ADS# is extended through the bus cycle. The alternate bus master sees the HLDA and performs its bus activity. HOLD is then driven inactive and the bus is returned to the Intel386™ EX Processor. At this point there is bus contention.

It is also possible for the following to occur when HOLD/HLDA arbitration is an issue: HOLD is driven active during the T1 or Tw of a valid bus cycle. The processor begins the next bus cycle and generates HLDA. HLDA is active for only one T-state. ADS# is extended through the bus cycle. The alternate bus master sees the HLDA and performs its bus activity. HOLD is then driven inactive and the bus is returned to the Intel386™ EX Processor. At this point there is bus contention.

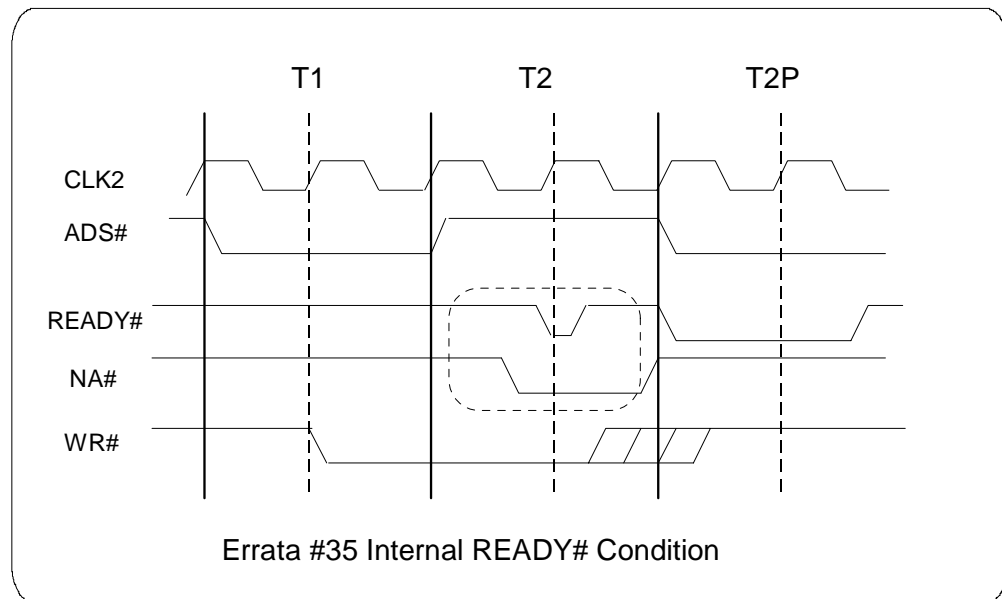
Implication: This errata applies to all applications programming zero wait states on chip select and generating an internal READY#. The temporary transition of READY# will only occur when switching from non-pipeline to pipeline mode.

Workaround: None. Do not trigger any external state machine on asserted READY# signal in T2 unless it occurs at the end of the T2 state where expected.

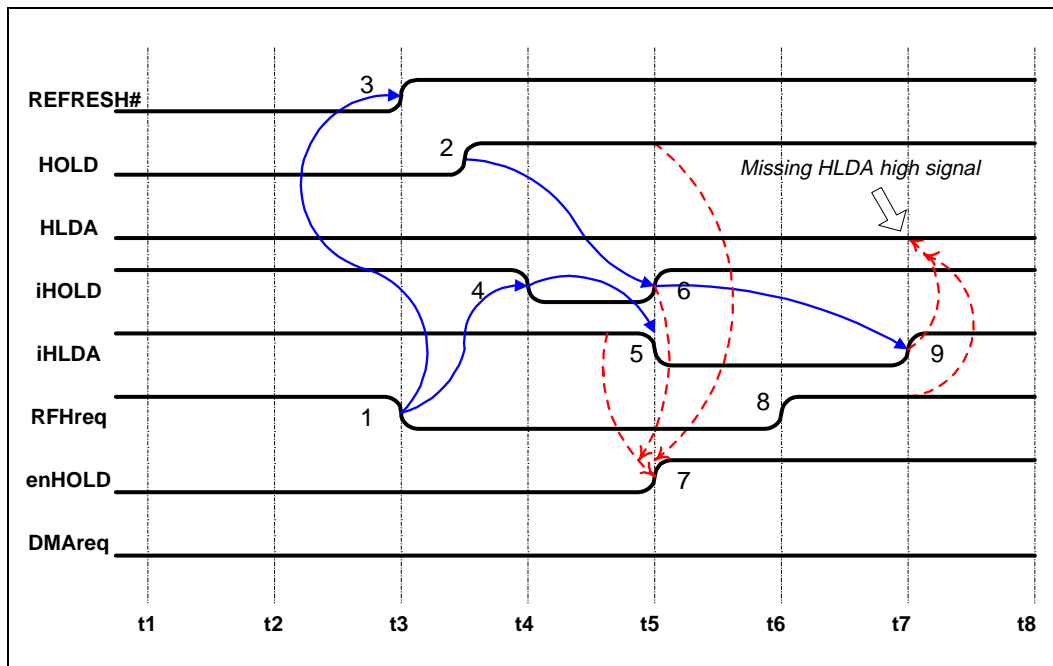
Figure 3. HOLD with Short REFRESH Interval

1. For system designs that use both HOLD and the internal Refresh Control Unit, the conditions are as listed in a, b, and c.
 - a. A small RFSCIR register value can cause the current refresh cycle and the next refresh cycle to almost overlap. Refer to Figure 3. When such a condition exists, there is a possibility that the refresh latency will cause a gap between the current refresh terminating (t3) and the next refresh (t6). This will create a problematic window if HOLD is asserted during that time. The minimum RFSCIR count that can be used without causing this problem depends on HOLD latency which is related to bus activity. HOLD latency is similar to refresh latency since they both generate an iHOLD request to the core. HOLD latency is basically a factor of wait states, locked cycles and special cycles such as interrupts. Worst case conditions should be used and can be calculated based on the information on page 6-37 (Hold Signal Latency) of the Intel386™ EX Embedded Microprocessor User's Manual (order number 272485-002). If the RFSCIR is a few cycles longer than the maximum calculated HOLD latency plus refresh duration, the problematic window will not exist. This condition should not happen in a typical customer design, since the RFSCIR value is usually larger than the worst case minimum value. To avoid this error, no workaround is needed as long as the RFSCIR value is greater than the recommended minimum value. The minimum RFSCIR can be roughly calculated as follows:

Figure 3 shows Condition #1a where an external HOLD and refresh request conflict can occur. The table below describes each signal name used:

Workaround: If the situations listed in conditions #1 and #2 cannot be avoided, the user needs to synchronize the external HOLD request such that it does not go active in an idle bus cycle or a refresh cycle. Alternately, HOLD can be deasserted if a HLDA is not received within a time-out period, as described in workaround 2. A third listing describes another recommended workaround when using HOLD, DMA, and REFRESH.

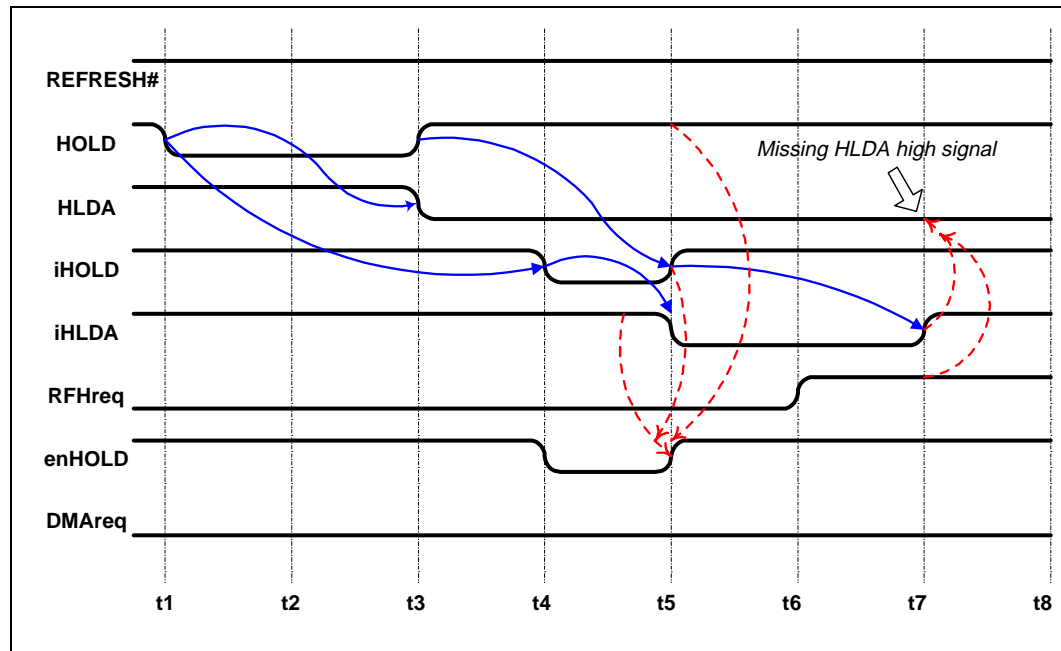
Figure 4. Quick HOLD Assert and Deassert with Slow REFRESH Interval

- b. HOLD is removed and reasserted within one bus cycle. Refer to Figure 4. This condition will cause the problematic window with fast iHOLD deassertion (t4) and assertion (t5). Note that if HOLD is deasserted because of pending REFRESH and reasserted again within one bus cycle, the problem will not occur since the iHOLD signal is never deasserted due to refresh. The reassertion of the HOLD would then be serviced upon completion of the refresh.

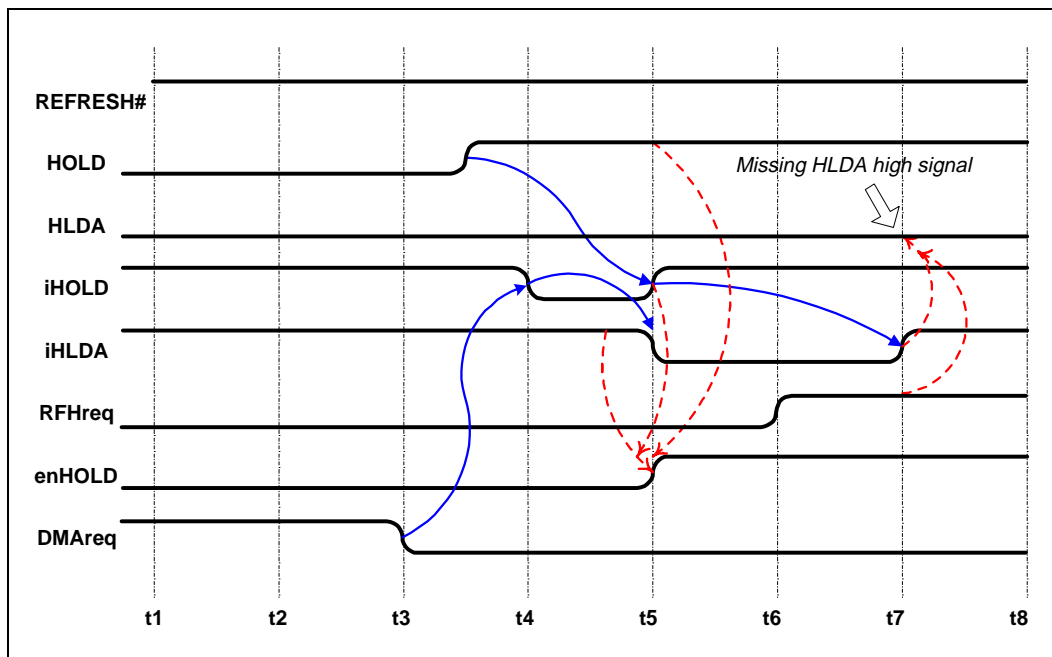
Figure 5. DMA, HOLD and REFRESH with Normal Interval

2. For system designs that use DMA, HOLD and REFRESH.

Note: DMAREQ is a signal internal to the processor. This signal is not always within the user’s control and could be internally deasserted, such as in autoinitialize mode. To avoid issues with this type of situation, it is recommended that the user deassert the external request DREQ after the last transfer has completed. It is further recommended that DREQ only be deasserted after a valid DMA acknowledge (DACK# goes low) has been returned. If a DREQ is held active and then deasserted during or shortly after the autoinitialize sequence, the problematic window can be induced and cause the errata to occur. See errata #28 for additional details on DMA programming restrictions.

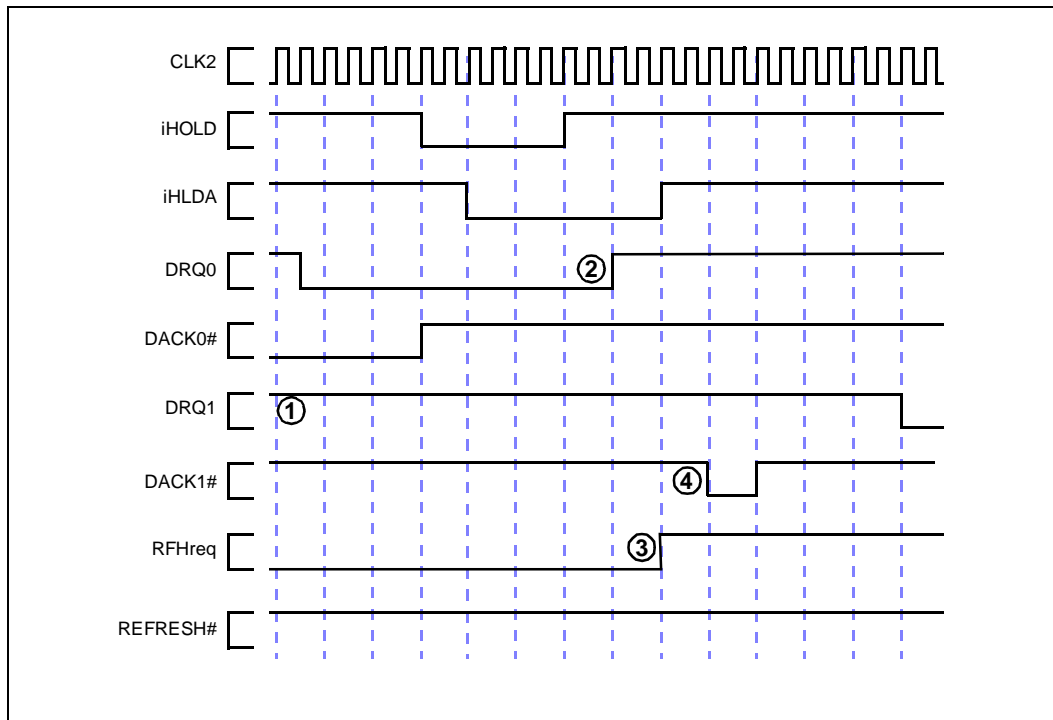
Figure 6. Two DMA Channels in Cascade Mode with Internal RCU Anomaly

The lower priority DMA channel requests the bus by asserting DRQ1 (see 1 in Figure 6). The higher priority channel requests the bus by asserting DRQ0 before the iHLDA has returned from the core (see 2 in Figure 6).

While the Bus Arbiter Unit is in the process of arbitrating priorities between the DMA channels, an internal refresh request signal (RFHreq) is asserted (see 3 in Figure 6) one PH1 cycle before the DMA acknowledge is granted (DACK1# asserted - see 4 in Figure 6). This scenario confuses the bus arbiter and the DMA acknowledge is given to the *lower* priority DMA channel. The arbiter believes the acknowledge was granted to the *higher* priority channel. The DACK1# is quickly taken away from the lower priority channel due to a pending refresh request. DMA channel 1 drops its request, apparently releasing the bus for a REFRESH cycle, but the arbiter is waiting for the higher priority channel to drop its request (DRQ0); this never occurs, since the acknowledge was never granted (DACK0#), and the system hangs.

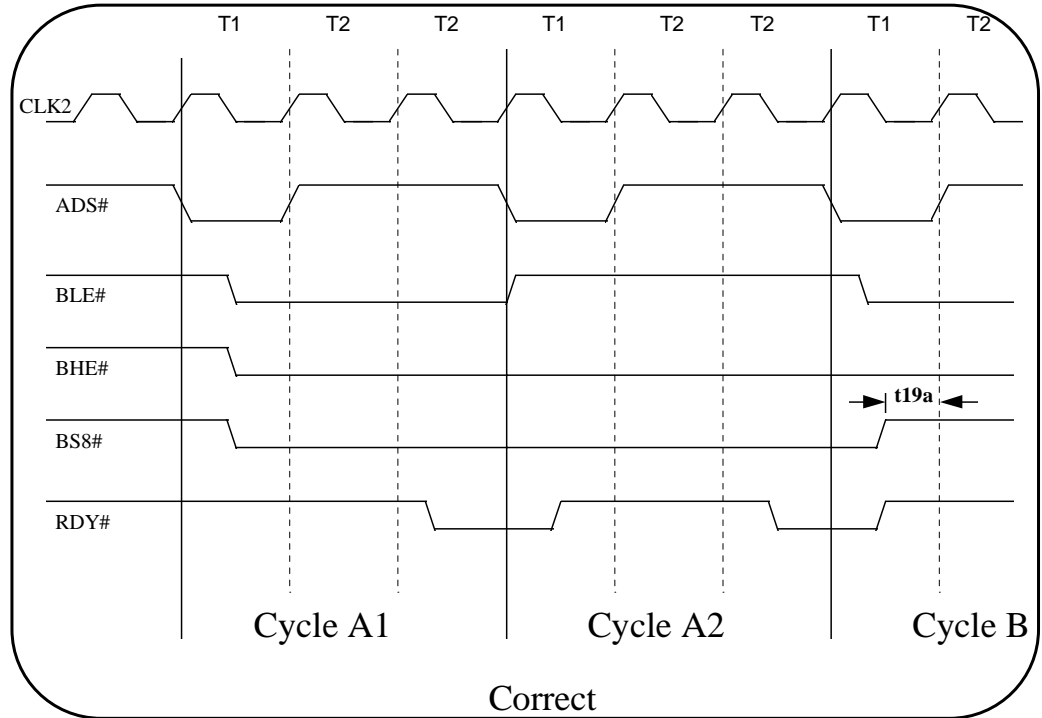
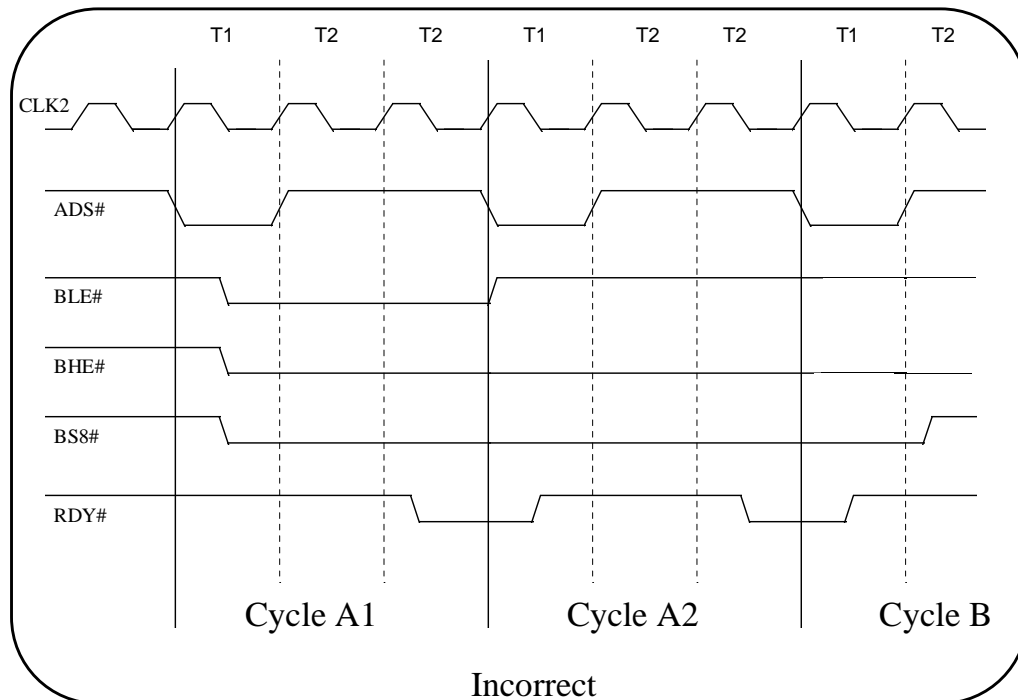
The reason this occurs is as follows: the processor latches the state of BS8# at the beginning of the first T2 of CYCLE B (to perform byte-steering within the processor) and resets this latch only in the next Ti or T1 state. Therefore, if BS8# is kept active into the first T2 of CYCLE B, then the byte-steering logic of the processor incorrectly assumes that CYCLE B is also a cycle to an 8-bit device. This causes the bytes to end up on the wrong data path.

Here are example waveforms demonstrating incorrect vs. proper latching of BS8#:
