i960[®] RM/RN I/O Processor

Specification Update

January 1999

Order Number: 273164-003

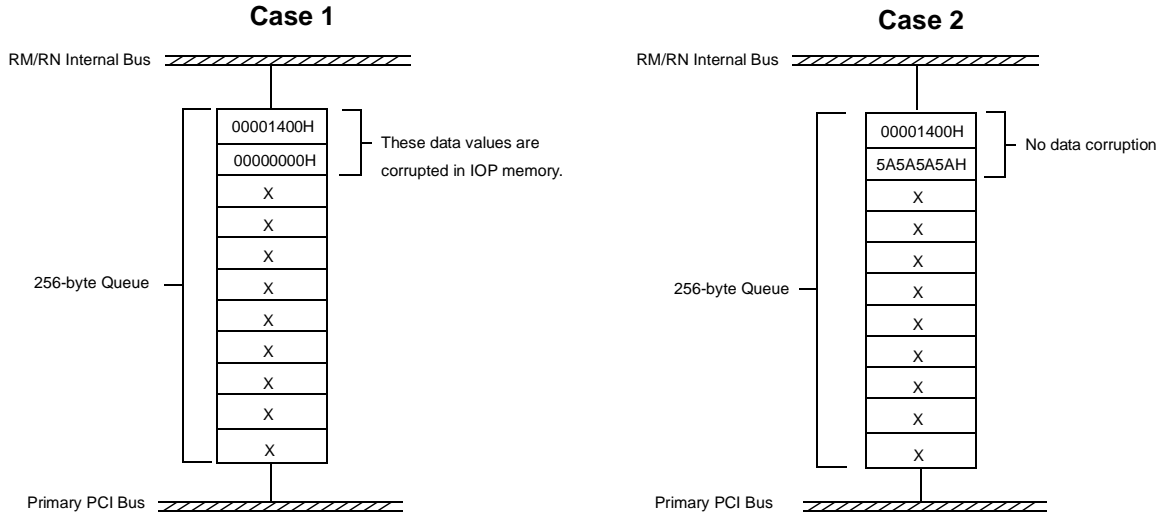
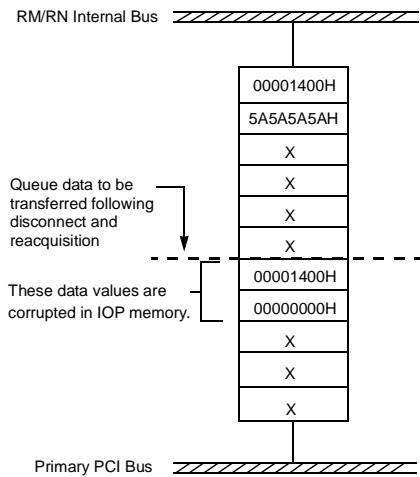
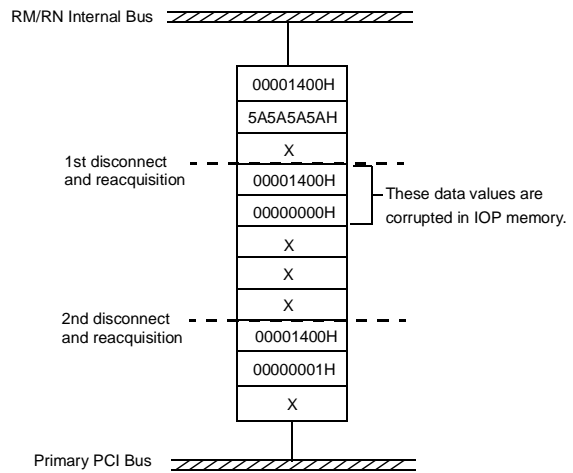
7. Data Corruption Occurs when Transfer Data Value Matches the Memory Mapped Register (MMR) Addresses of the DMA Channels

Problem: This problem appears across all 3 DMA channels: DMA Ch-0, Ch-1, and Ch-2. If the transfer data value falls within the MMR address range of the active DMA channel (1400H - 143FH for Ch-0, 1440H - 147FH for Ch-1, and 1480H - 14FFH for Ch-2), data corruption will occur.

Examples on page 14 describe the error condition.

Assumption: DMA channel 0 is used to transfer data from PCI to IOP memory.

Implication: Data corruption results when the data value matches the MMR address range of the active DMA channel.

Workaround: There are two possible workarounds for this errata:

- Use the Primary Address Translation Unit (PATU) to transfer data from Primary PCI to IOP memory and Secondary Address Translation Unit (SATU) to transfer data from Secondary PCI to IOP memory.
- Configure the Memory Controller Unit to execute in 32-bit mode. For further information, refer to Section 13.3.3 on page 13-14 of the *i960® RM/RN I/O Processor Developer's Manual* and to Table 4 in the 80960RM/RN I/O processor datasheets.

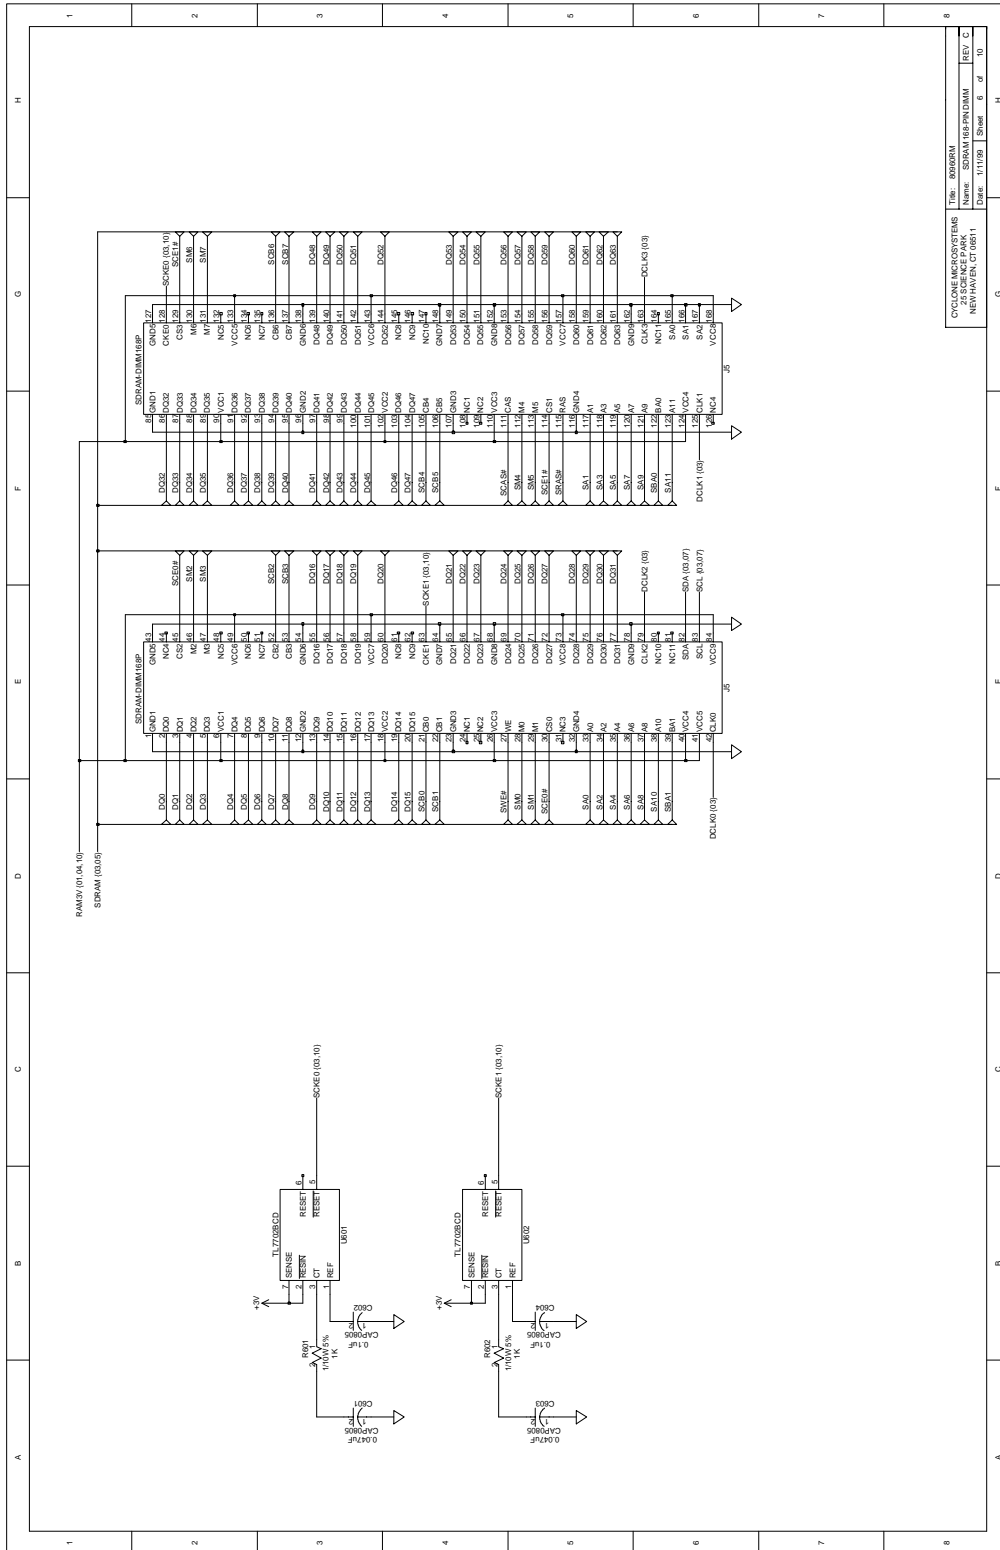
CYCLOCORE SYSTEMS
 1000 CENTURY PARK EAST
 NEW HAVEN, CT 06511
 Rev. 2: 8/2004
 Date: 11/1/00 Sheet 6 of 10

2. **Hooking up the SDRAM Clock Enable Outputs (SCKE0 and SCKE1) from the i960® RM/RN I/O Processor to the Clock Enable Inputs on the SDRAM DIMM in a Battery-Backup Application**

Problem: During the power-up reset sequence, the SDRAM devices occasionally enter a pseudo, self-refresh mode. This causes a lock-up condition on the SDRAM device. Normal operation of the SDRAM device which includes the SDRAM initialization sequence does not clear the lock-up condition.

Workaround: Ensure that the Clock Enable Inputs to the SDRAM DIMM are held low during power-up. This is accomplished as shown in the following circuit schematics (Sheet 6 – 80960RM schematics and Sheet 6 – 80960RN schematics in *i960® RM/RN I/O Processor Design Guide*).

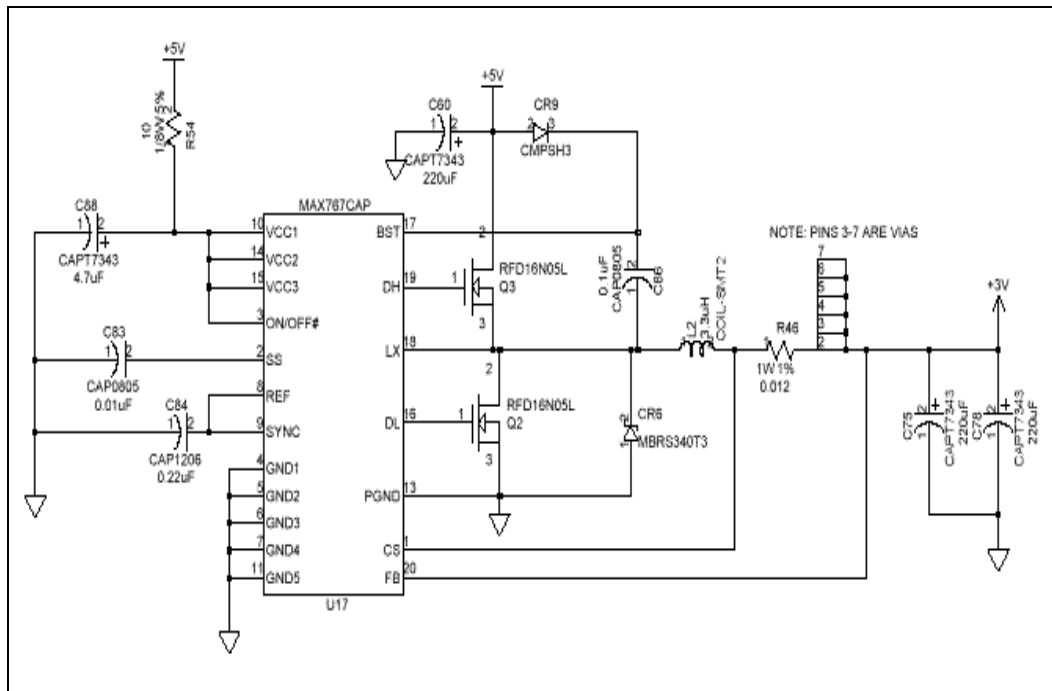
1. Page 1 of 80960RM Schematics and Page 1 of 80960RN Schematics

Issue: FETs Q2 and Q3 have had pinout changes as shown below.

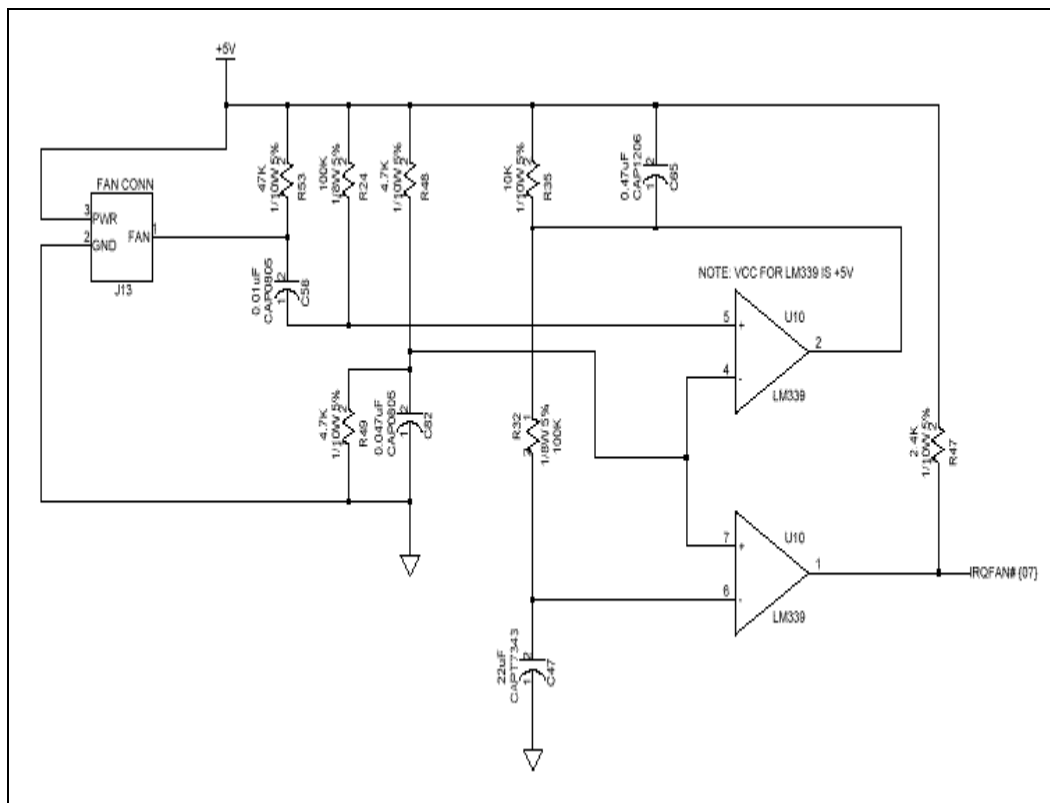
2. Page 1 of 80960RM Schematics and Page 1 of 80960RN Schematics

Issue: The fan connector, J13, has been changed by the manufacturer as shown below.
