Intel386™ DX MICROPROCESSOR SPECIFICATION UPDATE

Release Date: July, 1996

Order Number 272874-001

The Intel386™ DX Microprocessor may contain design defects or errors known as errata. Characterized errata that may cause the Intel386™ DX Microprocessor's behavior to deviate from published specifications are documented in this specification update.

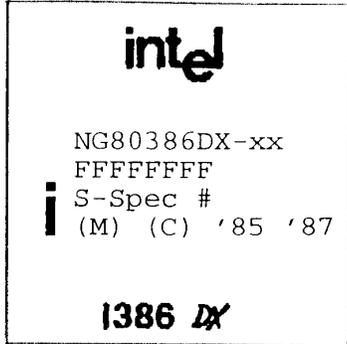
Markings

The F0 part is identified with the following marks:

i386 DX CPU-F0 (CHMOS IV)
